M60J SCHEMATIC Revision 2.00

PAGE	Content
1	Block Diagram
2	System Setting
3	CPU(1)_DMI, PEG, FDI, CLK, MISC
4	CPU(2)_DDR3
5	CPU(3)_CFG, RSVD, GND
6	CPU(4)_PWR
7	CPU(5)_XDP
16	DDR3 SO-DIMM_0
17	DDR3 SO-DIMM_1
18	DDR3 CA_DQ VOLTAGE
19	VID CONTROLLER
20	PCH_IBEX(1)_SATA, IHDA, RTC, LPC
21	PCH_IBEX(2)_PCIE, CLK, SMB, PEG
22	PCH_IBEX(3)_FDI, DMI, SYS_PWR
23	PCH_IBEX(4)_DP, LVDS, CRT
24	PCH_IBEX(5)_PCI, NVRAM, USB
25	PCH_IBEX(6)_CPU, GPIO, MISC
26	PCH_IBEX(7)_POWER, GND
27	PCH_IBEX(8)_POWER, GND
28	PCH_SPI ROM, OTH
29	CLK_ICS9LRS3197
30	EC_IT8502(1/2)
31	EC_IT8502(2/2)KB, TP, FP
32	RST_Reset Circuit
33	HANKSVILLE
34	LAN-AR8131
36	AUD-ALC269
37	AUD-HEADPHONE & SPEAKER
40	CB_R5U230
43	CB_NewCard
44	BUG_Debug
45	CRT_LCD Panel
46	CRT_D-Sub
47	Display Port
48	TV_HDMI
50	FAN_Fan & Sensor
51	XDD_HDD & ODD
52	USB_USB Port *2
53	MINICARD(WLAN)
56	LED_Indicator
57	DSG_Discharge
58	PW_PROTECT
60	DC_DC & BAT Conn.
61	BT_Bluetooth
64	TUN_TV Tuner
65	ME_Conn & Skew Hole
66	ESA_ESATA

67	PCH_XDP, ONFI
70	VGA_MXM
80	PW_VCORE(MAX17034)
81	PW_SYSTEM(MAX17020)
82	PW_I/O_VTT_CPU&+1.1VM
83	PW_I/O_DDR & VTT& +1.8VS
84	PW_I/O_3VM & ME_+VM_PWEGD
86	PW_+VGFY_CORE(MAX17028)
88	PW_CHARGER(MAX17015)
90	PW_DETECT

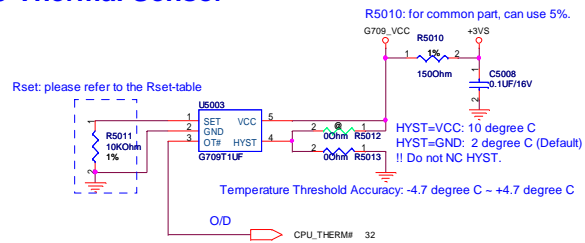
CPU Thermal Sensor

Layout note:
Place U5003 at the center of the CPU socket.

$$Rset(Kohm)=0.0012T^2T-0.9308T+96.147$$

Rset table:		
T=	degree C , Rset=	Kohm
100		15.07
101		14.38
102		13.69
103		13.01
104		12.32
105		11.64
106		10.97
107		10.29
107.43		10.00 default
109		9.95
110		8.28
111		7.61
112		6.95
113		6.29
114		5.23
115		4.98
